Strengthening of Marine Structures

Case study: Pile strengthening, Ireland

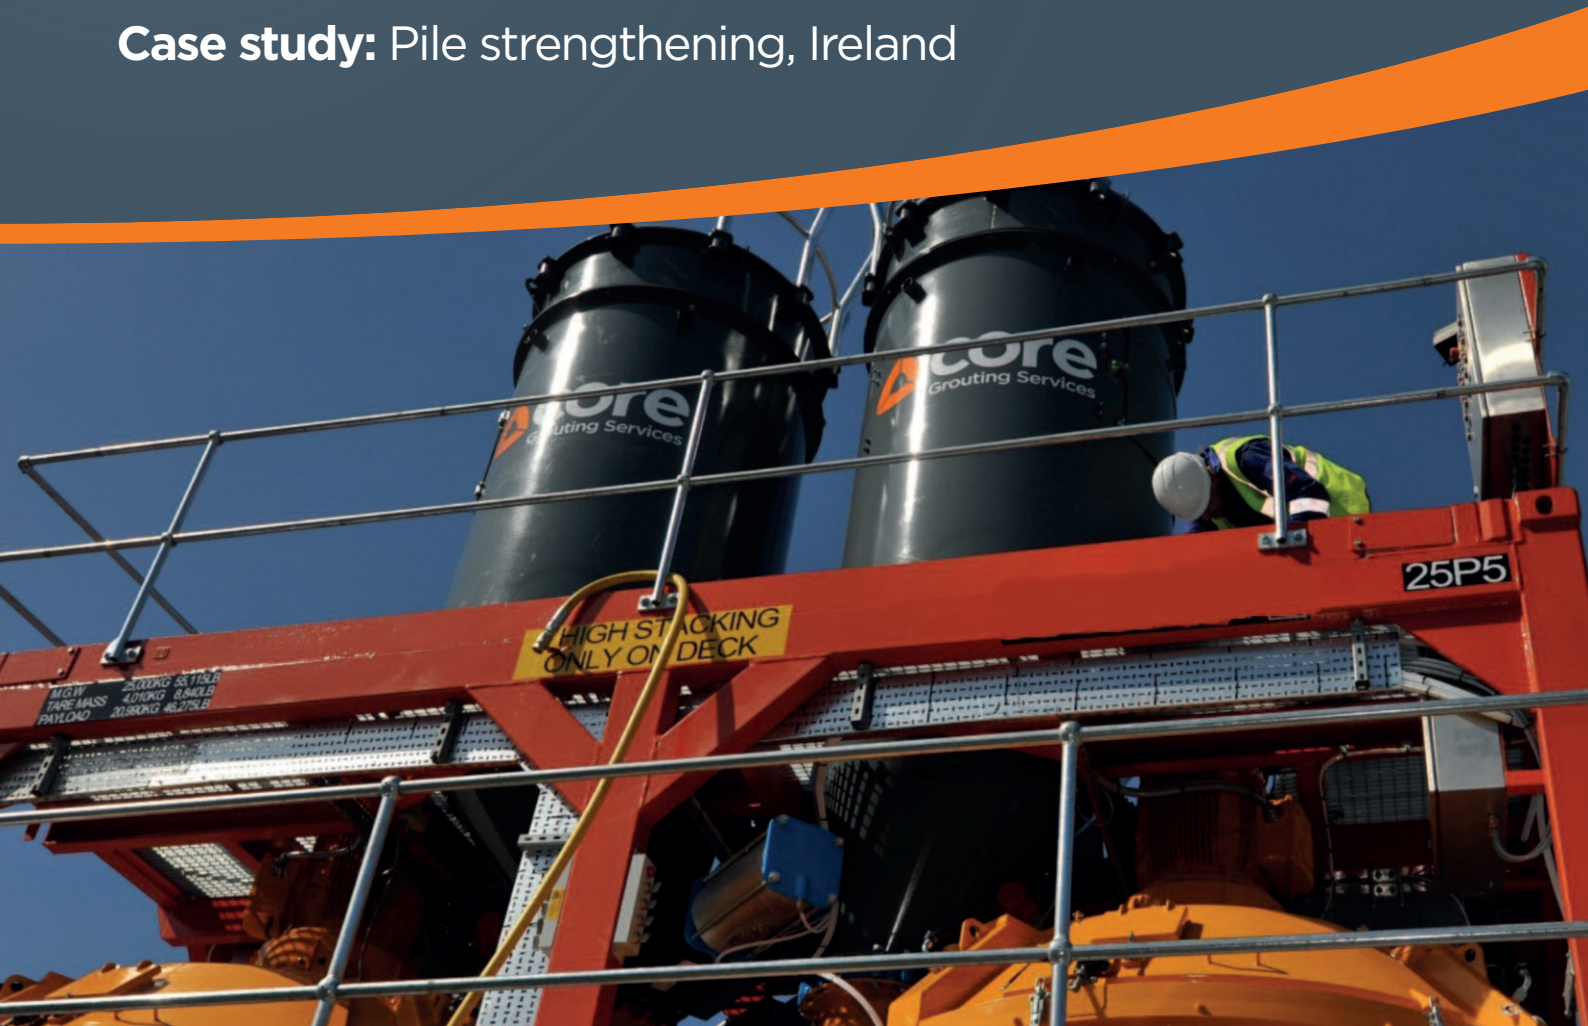
Client identified that steel members supporting a marine structure were becoming corroded. This resulted in reduced load bearing capability of the structure. Core was requested to provide & install a high strength sulphate free grout to strengthen the structure and reduce future corrosion

- Piles cleaned & reinforcing structure installed around piles
- Grout hose connected to bottom of formworks
- High strength grout mixed and pumped to structure
- Hose disconnected and moved to next location

- Strengthened piles increased the load bearing capability of the structure
- High strength grout prevents future corrosion of steel structure

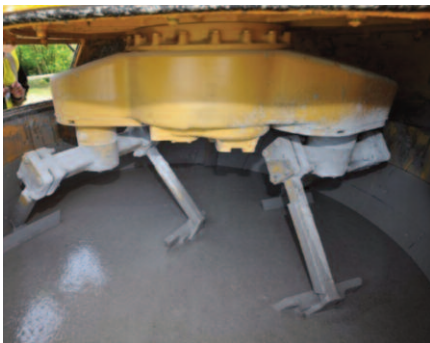
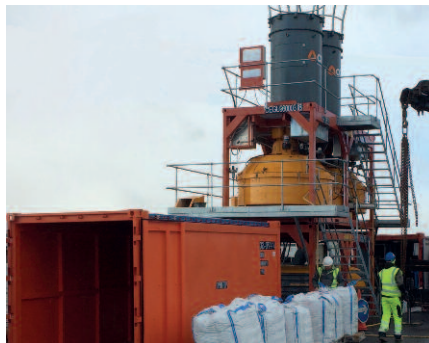
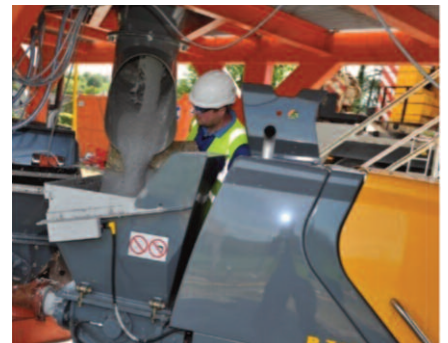
- Grout material was quality controlled and testing using Core's offshore laboratory
